Minnesota Department of Natural Resources  
Division of Fish and Wildlife  
Section of Fisheries

Stream Survey Report

Seven Mile Creek 2014

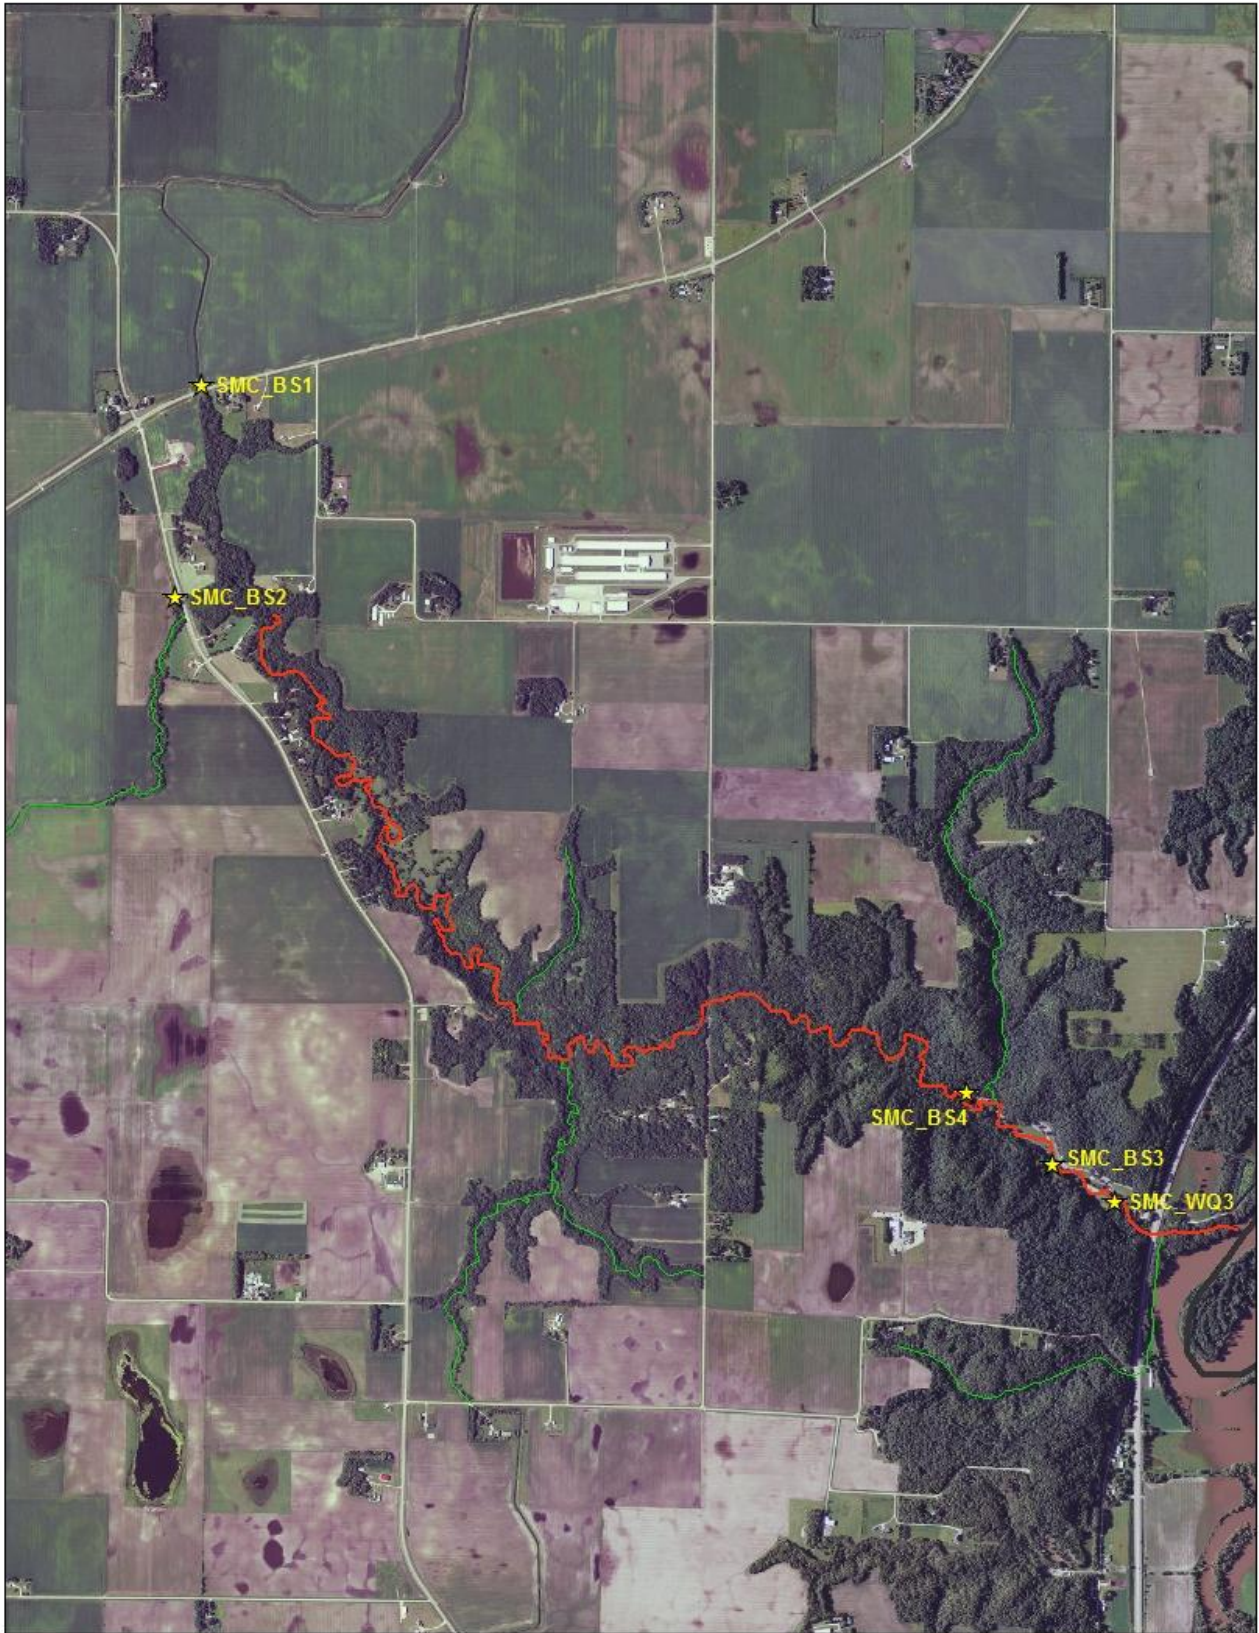
**Figure 1.** Sampling stations for the 2014 Seven Mile Creek special assessment.

**13. Reason for Survey:** To assess the fish community in conjunction with restoration measures being implemented as part of the Seven Mile Creek Watershed Program. Four standardized stations (SMC\_BS1 - SMC\_BS4) were sampled (Fig. 1). A Seven Mile Creek Watershed Program Monitoring Plan was written in December, 2011 and much of this report follows those protocols.
